# Inspection Report

## Smart Homebuyer

**Ace Home Inspection, LLC**

<b>Date:</b> 8/4/2009	<b>Time:</b> 09:30 AM	<b>Report ID:</b> 1234567
<b>Property:</b>	<b>Customer:</b> Smart Homebuyer	<b>Real Estate Professional:</b> Tess "Sold" Realty Company

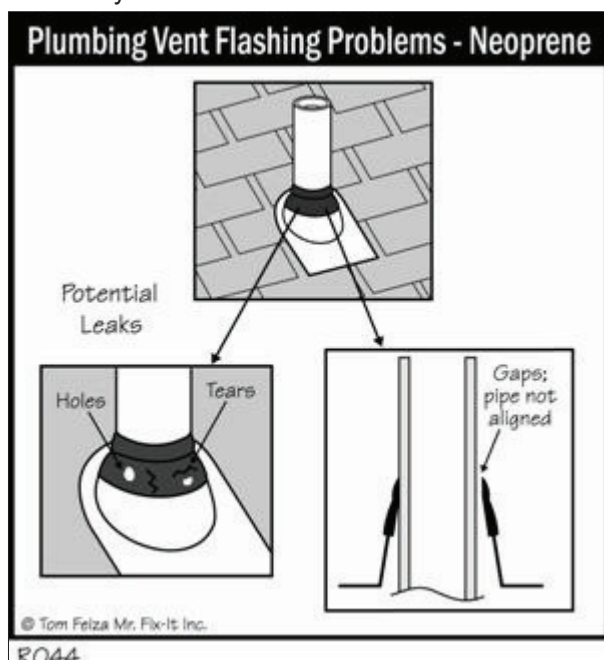
1.1 Picture 1

The plumbing vent stack protective boot has deteriorated and is cracked. This condition may allow water to run down the stack and collect in the home creating water damaged areas. I recommend replacement of protective boot; this work should be done by a licensed roofer.

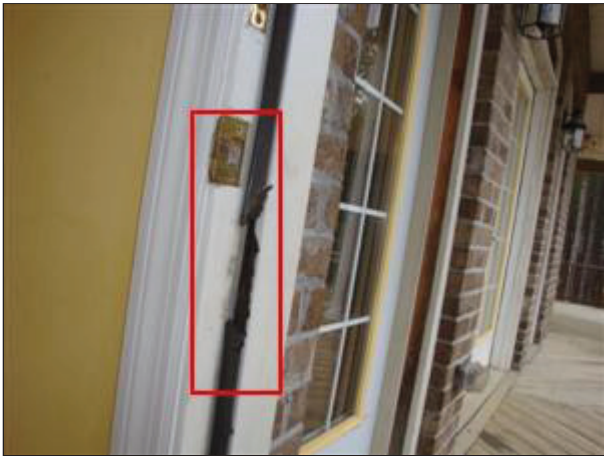
2.1 Picture 1

Rear door of home is not sealed tightly due to damaged weather strip. Gaps allow conditioned air to escape and decrease efficiency. Recommend replacement of damaged weather strip.

Rear door of home is not sealed tightly due to damaged weather strip. Gaps allow conditioned air to escape and decrease efficiency. Recommend replacement of damaged weather strip.

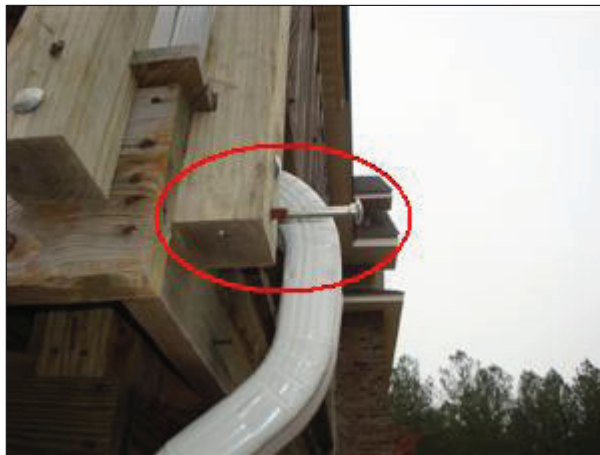
2.3 Picture 1

The deck post connection on right corner of deck is not secured. This condition considerably weakens guard-rail system. Recommend repairs to post connection to ensure deck guard-rail integrity.

The deck post connection on right corner of deck is not secured. This condition considerably weakens guard-rail system. Recommend repairs to post connection to ensure deck guard-rail integrity.

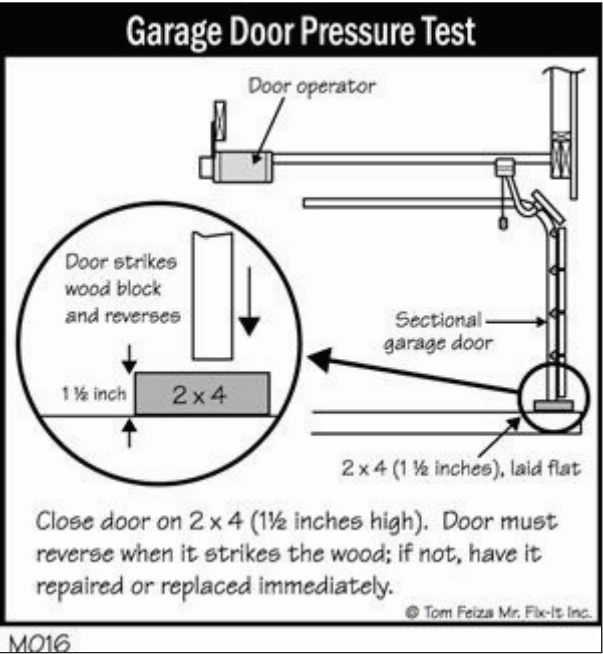
3.5 Picture 1

Repair, Safety Issue: The garage door opener did not automatically reverse under resistance to closing. There is a serious risk of injury, particularly to children, under this condition. Improvement may be as simple as adjusting the sensitivity control on the opener. This should be dealt with immediately. Information on garage door openers is available from the Consumer Product Safety Commission at 1-800-638-2772.

Repair, Safety Issue: The garage door opener did not automatically reverse under resistance to closing. There is a serious risk of injury, particularly to children, under this condition. Improvement may be as simple as adjusting the sensitivity control on the opener. This should be dealt with immediately. Information on garage door openers is available from the Consumer Product Safety Commission at 1-800-638-2772.

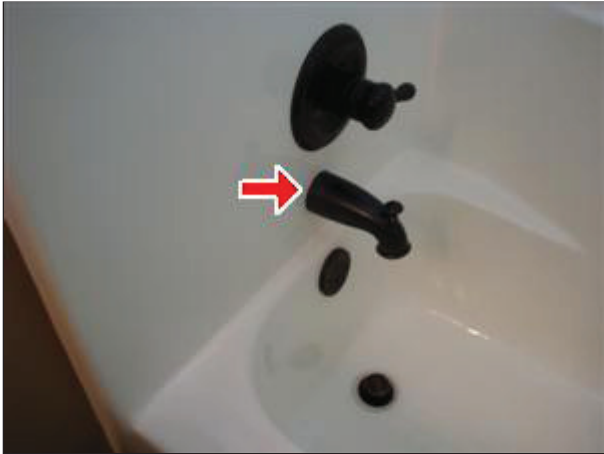
6.1 Picture 1

The tub faucet in the hallway bathroom is leaking. Recommend repairs by a licensed plumber.

The tub faucet in the hallway bathroom is leaking. Recommend repairs by a licensed plumber.

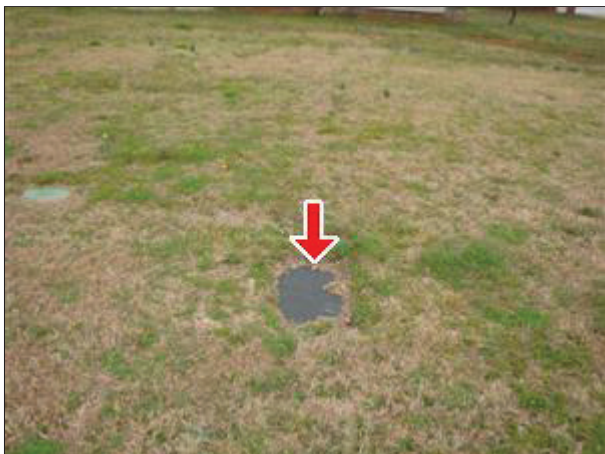
6.3 Picture 1

Water shut-off located in front yard near street.

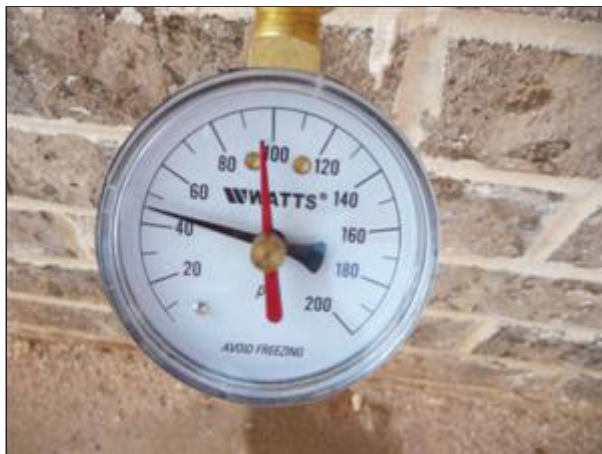
6.3 Picture 2

Water pressure is 46 psi. Residential water pressure should be 40-80 psi. Good pressure.

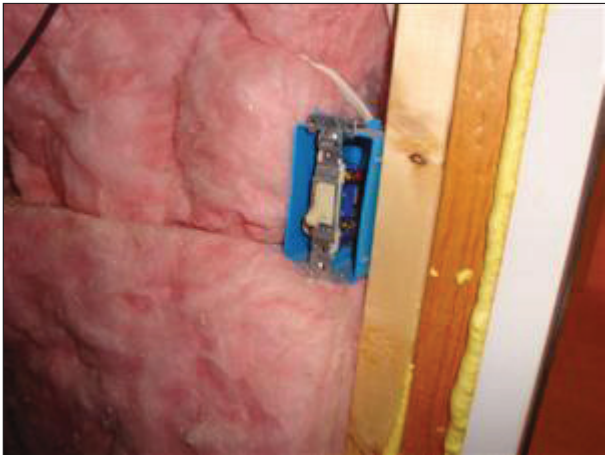
7.3 Picture 1

Light switch cover missing inside garage. Open electrical wiring is considered a shock hazard. Recommend installing missing cover(s). Any work involving wiring or the possibility of contacting wiring should be done by a licensed electrician.

Light switch cover missing inside garage. Open electrical wiring is considered a shock hazard. Recommend installing missing cover(s). Any work involving wiring or the possibility of contacting wiring should be done by a licensed electrician.

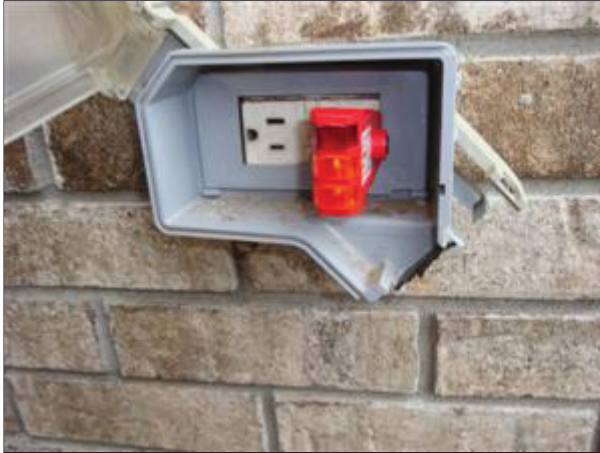
7.5 Picture 1

- 🏠 One GFCI (Ground Fault Circuit Interrupter) outlet on the rear of home would not "trip" when tested. Power is available to the outlet. Recommend that a qualified licensed electrical contractor correct wiring so outlet will operate as intended, affording additional circuit protection in case outlet gets wet.

One GFCI (Ground Fault Circuit Interrupter) outlet on the rear of home would not "trip" when tested. Power is available to the outlet. Recommend that a qualified licensed electrical contractor correct wiring so outlet will operate as intended, affording additional circuit protection in case outlet gets wet.

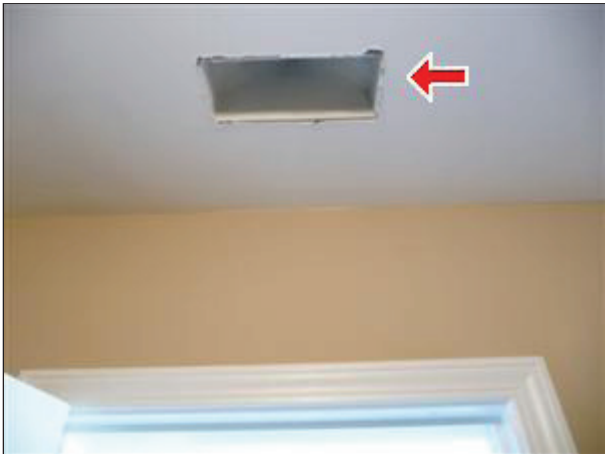
8.3 Picture 1

The ceiling register is missing in the upstairs front bedroom closet. Recommend installing the appropriate ceiling register.

The ceiling register is missing in the upstairs front bedroom closet. Recommend installing the appropriate ceiling register.

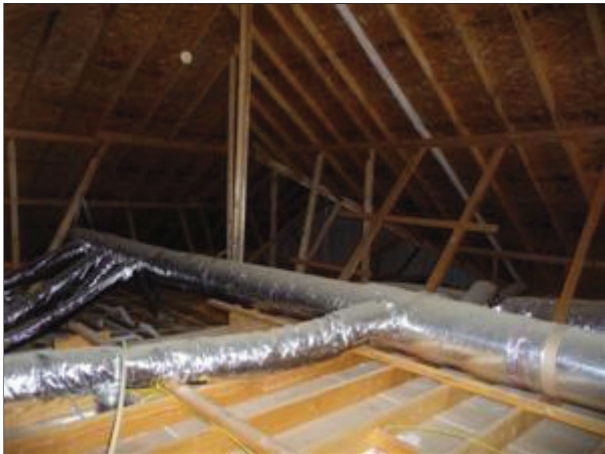
9.0 Picture 1

There are large areas of missing insulation in attic. The U.S. Department of Energy minimum recommended R-value for our area is R-30 which is approximately 13 inches of blown-in insulation. Recommend adding insulation to conserve energy.

There are large areas of missing insulation in attic. The U.S. Department of Energy minimum recommended R-value for our area is R-30 which is approximately 13 inches of blown-in insulation. Recommend adding insulation to conserve energy.

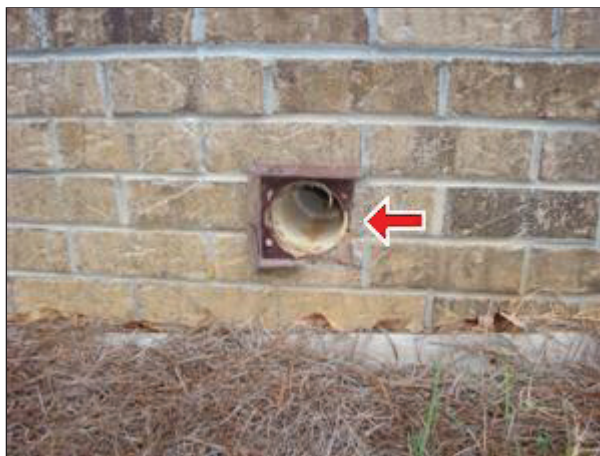
9.2 Picture 1

The dryer vent hood is missing outside (right exterior wall). The dryer vent hood will keep pests and water out of dryer vent system and increase the efficiency of the dryer vent system. I recommend installing the appropriate dryer vent hood.

The dryer vent hood is missing outside (right exterior wall). The dryer vent hood will keep pests and water out of dryer vent system and increase the efficiency of the dryer vent system. I recommend installing the appropriate dryer vent hood.

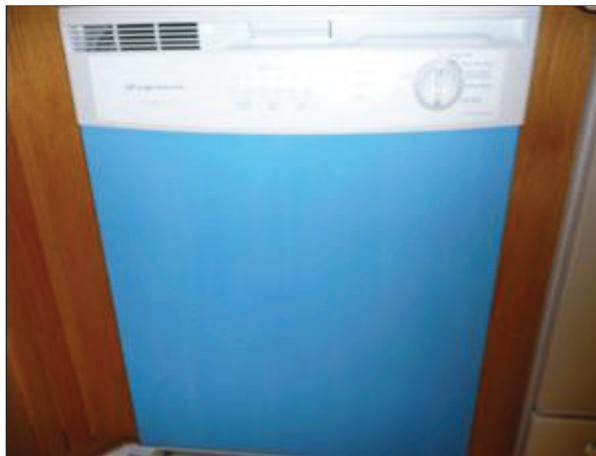
10.0 Picture 1

**(Dishwasher life expectancy is 5-12 years)**

The dishwasher is loose and should be secured to underside of countertop (using a proper length screw) or side restraints installed. I recommend repair as necessary.

The dishwasher is loose and should be secured to underside of countertop (using a proper length screw) or side restraints installed. I recommend repair as necessary.
